**Correlation of Rock Quality Designation and Rock Scour  
Around Bridge Piers and Abutments Founded on Rock**

**Research Report KTC-99-57  
KYSPR-94-157**

**Tommy C. Hopkins**  
Chief Research Engineer  
Head of Geotechnology

September 1999

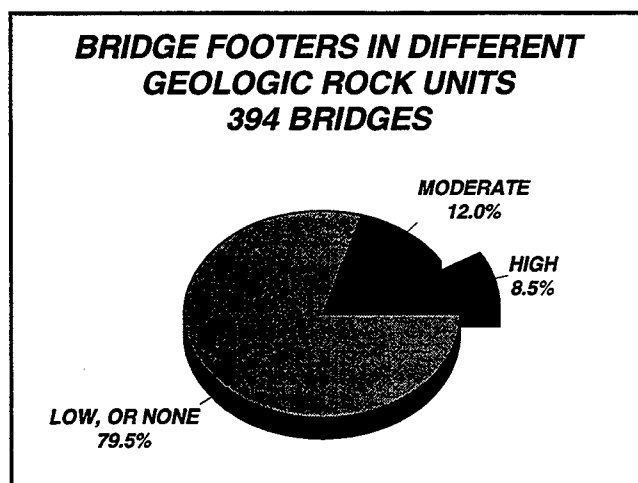
**Figure 10.** Preliminary ratings of rock scour at 394 randomly selected bridges.

scour conditions in the preliminary rating were divided into three broad categories: low (none or nominal scour); moderate (some scour close to or adjacent to footer); and high (deep scour located adjacent to, or undercutting the footer). As indicated from the preliminary ratings, Figure 10, about

8.5 percent of the 394 bridges (some 30 locations) were rated "high." The rock scour condition at some 12 percent of the locations was rated "moderate," while the condition of about 80 percent of the locations was rated "low," or none. County locations of the "high" classified bridges are shown in Figure 11. Geology of the streambed rock units at the different locations consisted of clayey shales, siltstones, sandstones, hard shales, sandstones, interbedded limestone and shale, and limestone with shale partings. Two factors which would appear to be significant to the development of rock scour are the geology of the exposed rock of the streambed and age of the bridge. To examine the influence of geology (sedimentary rocks only) on the development of rock scour, an analysis of

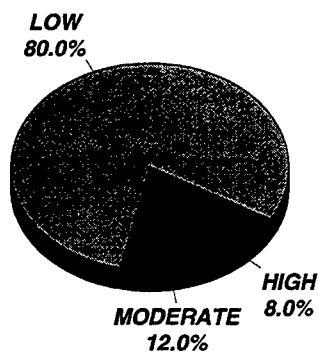
**Figure 12.** Rock scour ratings of bridge abutments or pier footers constructed in Kope or Fairview Shale.

Formation consists of limestone layers while the major portion of the Kope Formation consists of clay shale. Numerous highway engineering problems (landslides, pavement failures, etc.) are associated with these shales (Hopkins, 1983; 1988). The slake-durability index of these shales ranges from about zero to 20 percent. Jar slake index of this material is zero -- the material, after drying, degrades into flakes when exposed to water. Hence, it was anticipated that rock scour would be prevalent in areas containing this exposed clayey shale. However, the scour condition of 25 bridges in the Kope and Fairview Shales, Figure 12, was rated "high" at only 8 percent, or two bridges -- essentially the same percentage observed for the larger group of bridges, as shown in Figure 8.

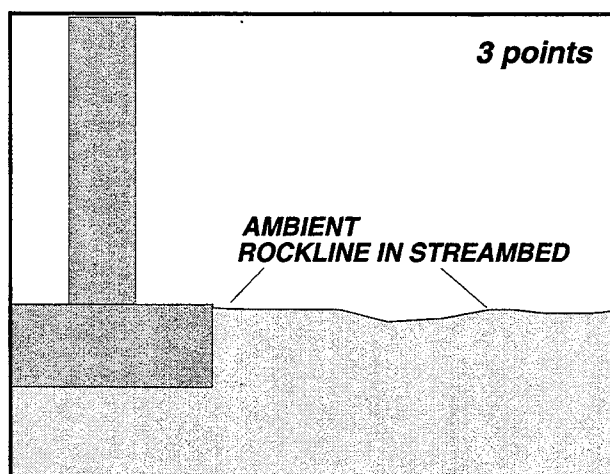
**Figure 16.** None or slight rock scour.

16, no scour is apparent and the scour condition is rated low, or given a numerical value of zero to three points. In Figure 17, a local scour hole is visible around the footer. However, the bottom of the footer is not readily visible. In this situation, erosion of the rock unit adjacent to the footer may be actual erosion or the hole may be due to over excavation. This condition is given a moderate rating and assigned a value of about nine points.

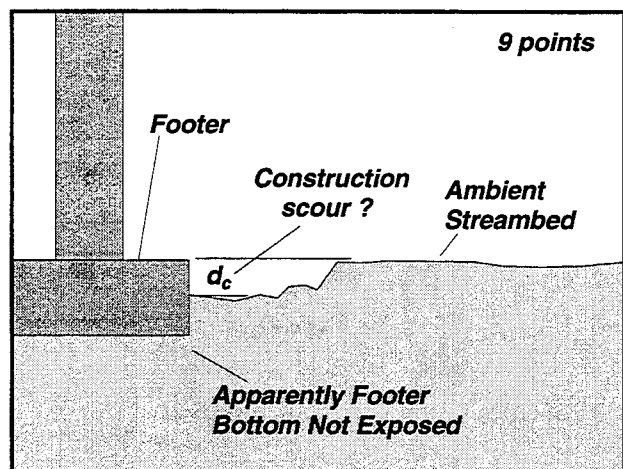
**Figure 17.** Small hole next to the footer.

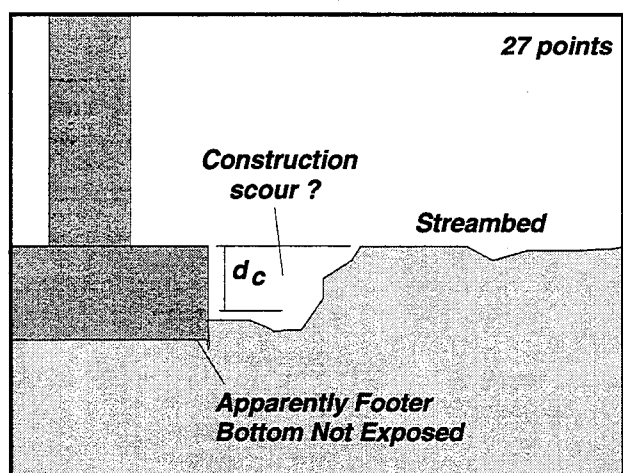
**Figure 18.** Scour depth near the bottom of the footer.

In Figure 18, the bottom of the apparent scour hole appears to be at the same level as the bottom of the footer -- a condition that is rated as high, or a value of 27 points is assigned to this situation. Finally, as shown in Figure 19, whenever the bottom of the scour is at the bottom of the footer or below, the condition is rated very high and a value of about 81 points to 100 points would be assigned to this situation. In addition to a maximum  $d_c$  score, a quantitative measurement,  $d_s$ , as shown in Figure 20, from the bottom of the apparent scour to the exposed footer line is taken and scored in this case, as illustrated in Table 2.

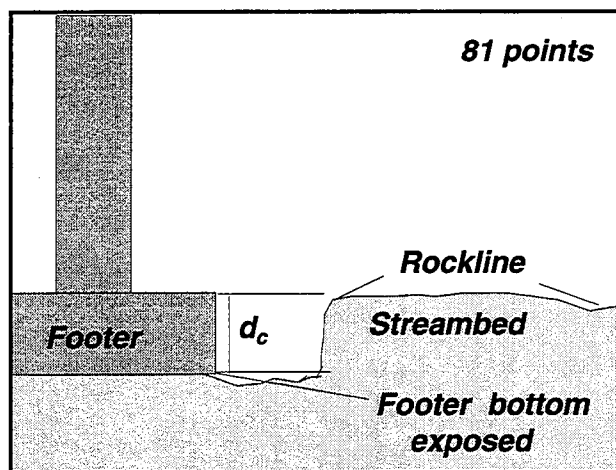
Figure 19. Scour depth at the bottom of the footer.

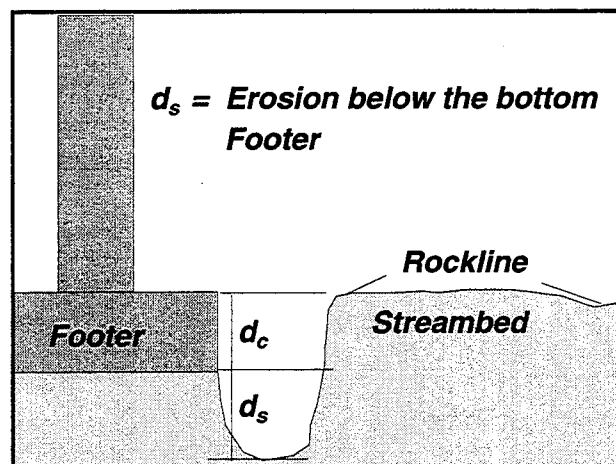
Figure 20. Scour depth below bottom of footer.

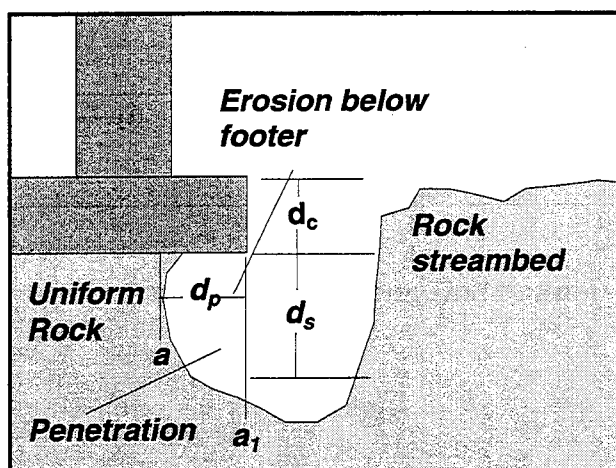
Figure 21. Erosion penetration under footer foundation.

The third factor considered critical to the performance and service of the abutment or pier footer is erosion penetration beneath the footer. Penetration of rock scour is the horizontal distance (line  $a-a_1$  in Figure 21) measured from the face of the footer to the eroded face of the rock unit beneath the footer. Two different conditions have commonly been observed in Kentucky (sedimentary rocks). In the first case, Figure 21, the rock unit is uniform in structure and erosion occurs directly below the footer. The second case, Figure 22, involves a footer resting on interbedded layers of hard, or durable,

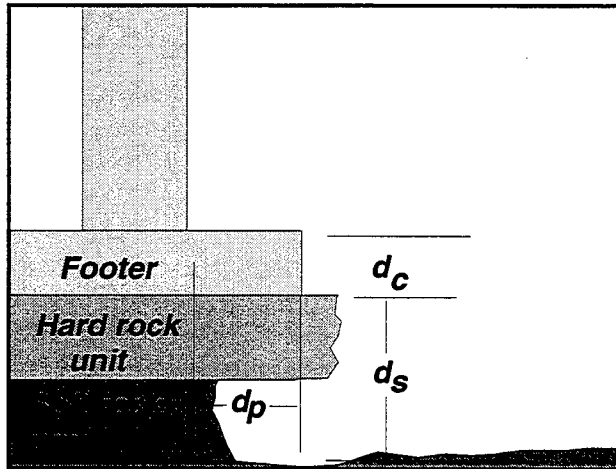
**Figure 22.** Erosion penetration occurring within interbedded layers.

and soft, nondurable, rock units. Erosion penetration occurs indirectly as a result of differential erosion between the durable and nondurable units. Generally, the footer is oftentimes located on the durable rock unit. However, if the hard member is thin, the footer may be undercut as the softer member erodes. If the penetration is merely adjacent or zero, then the condition is rated low. When penetration is about two inches, the condition is rated moderate. For a penetration of two to six inches, the condition is serious. When the penetration is greater than 6 inches, the condition is rated very serious. Although these penetration values were arbitrarily selected, they

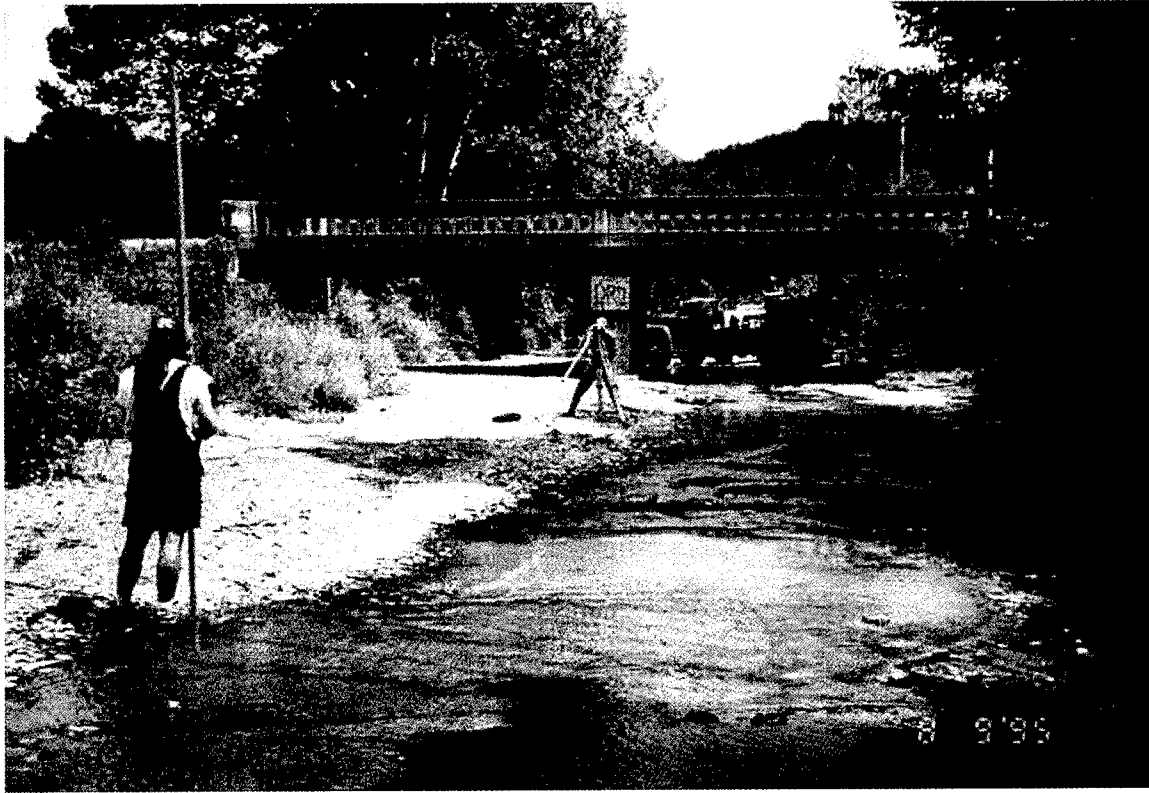
## Adair County KY 704 Burns Creek

Constructed 1952  
Scour Rating = 106  
Small (1 in.) Penetration Scour at  
Corner of Pier Footer  
2 in. Scour Below Footer

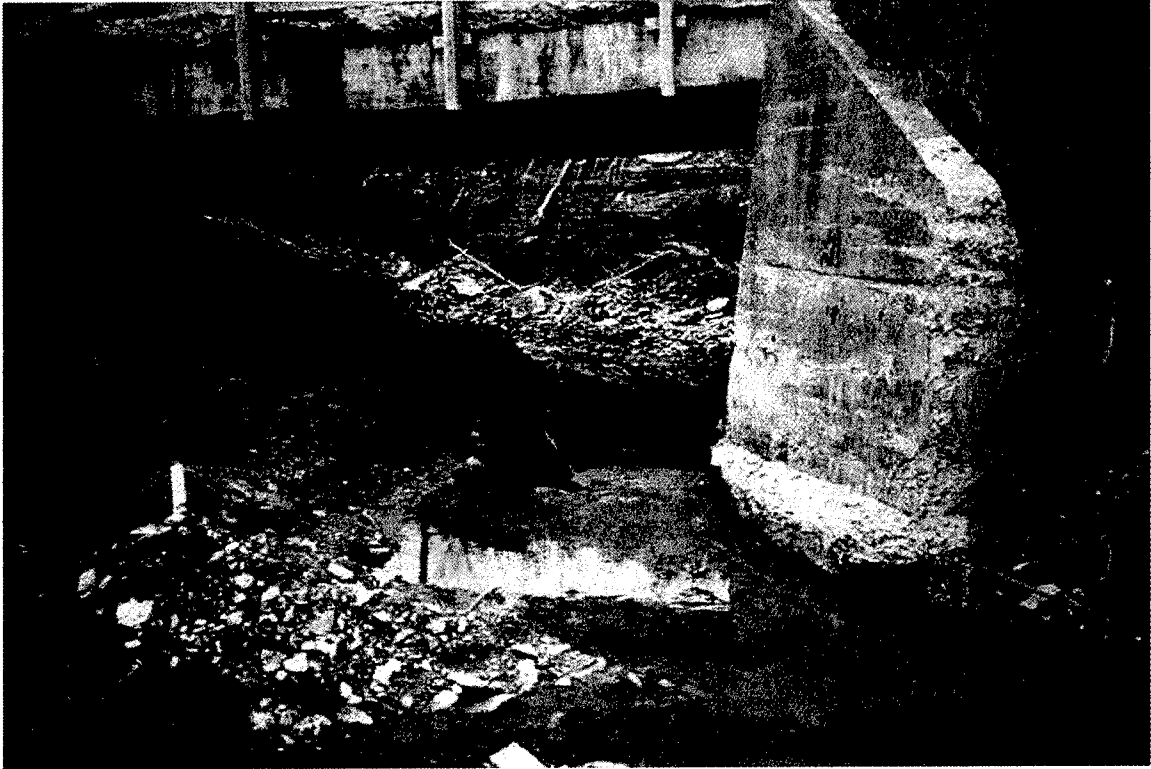
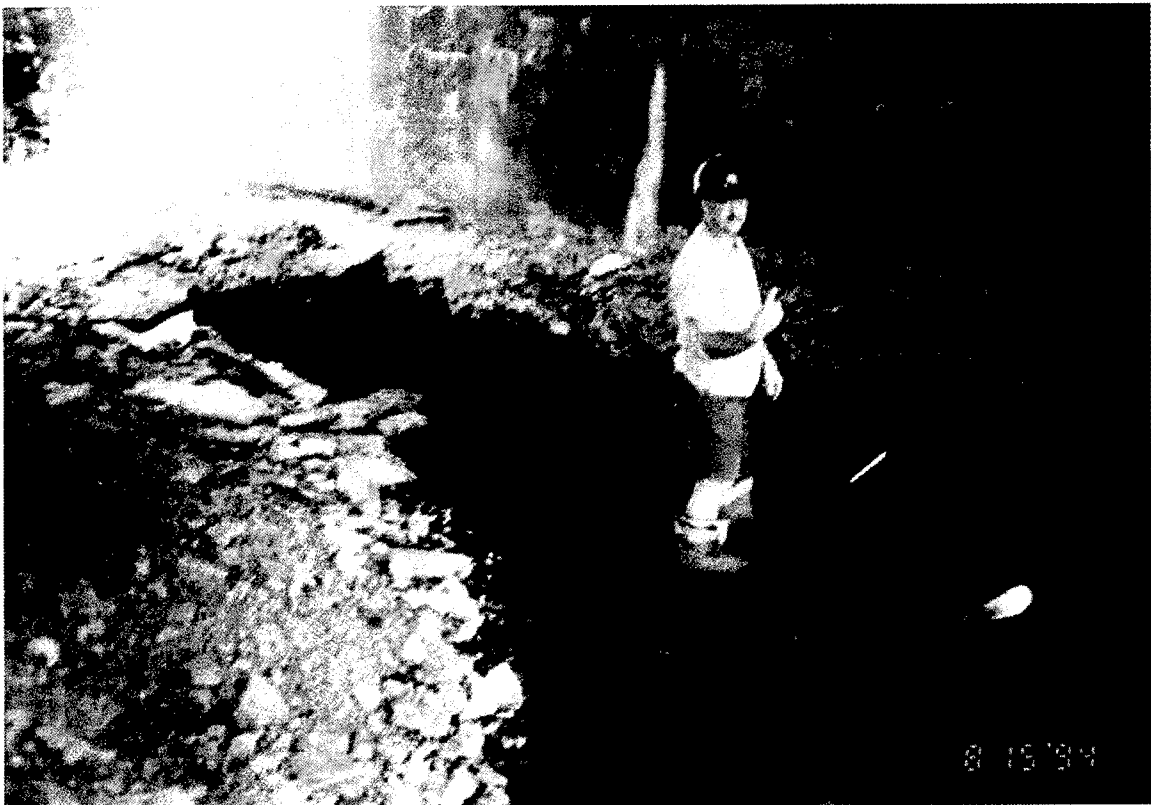
# Bath County US 60 Hurricane Creek

**Bridge # 6-B00023**  
**Constructed 1925**

**Scour Rating = 458**  
**2 Ft. Penetration Scour Below Footer**

**Bridge Replaced in 1996**

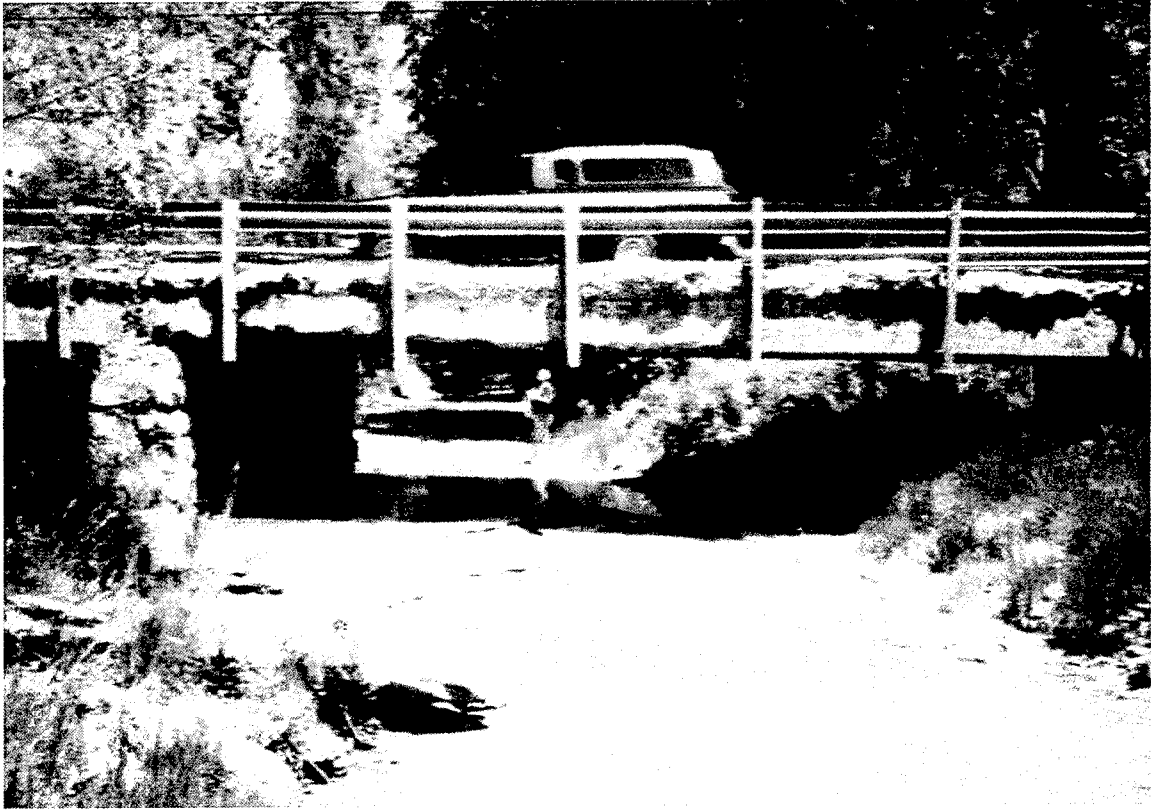
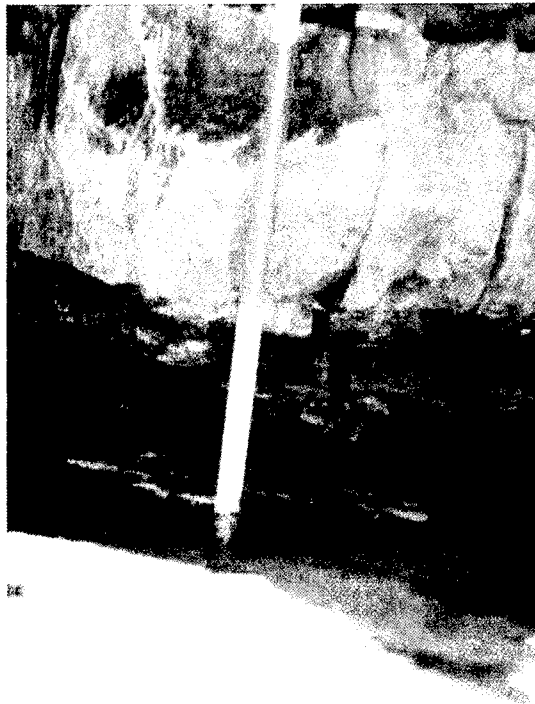
**Bullitt County US 31 W Hough Run Creek**

**Bridge # 15-B00007**

**Constructed 1924**

**Route being reconstructed in 1996, 1997**

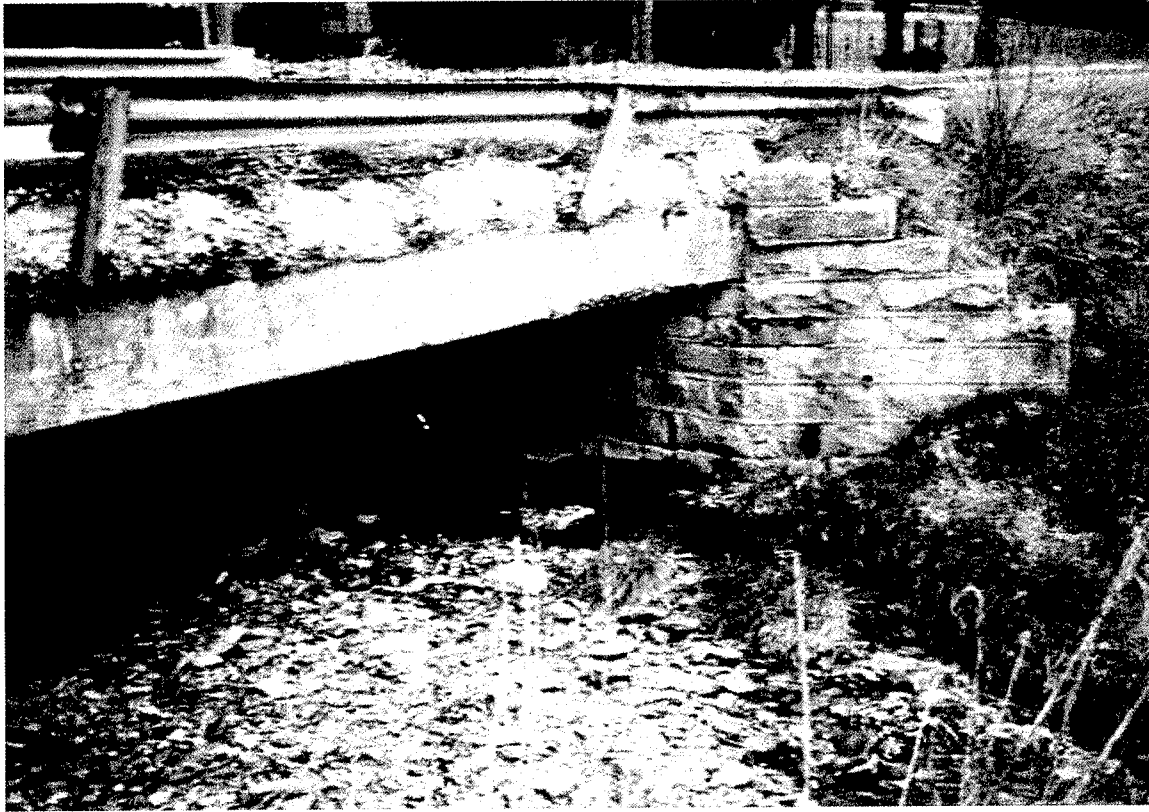
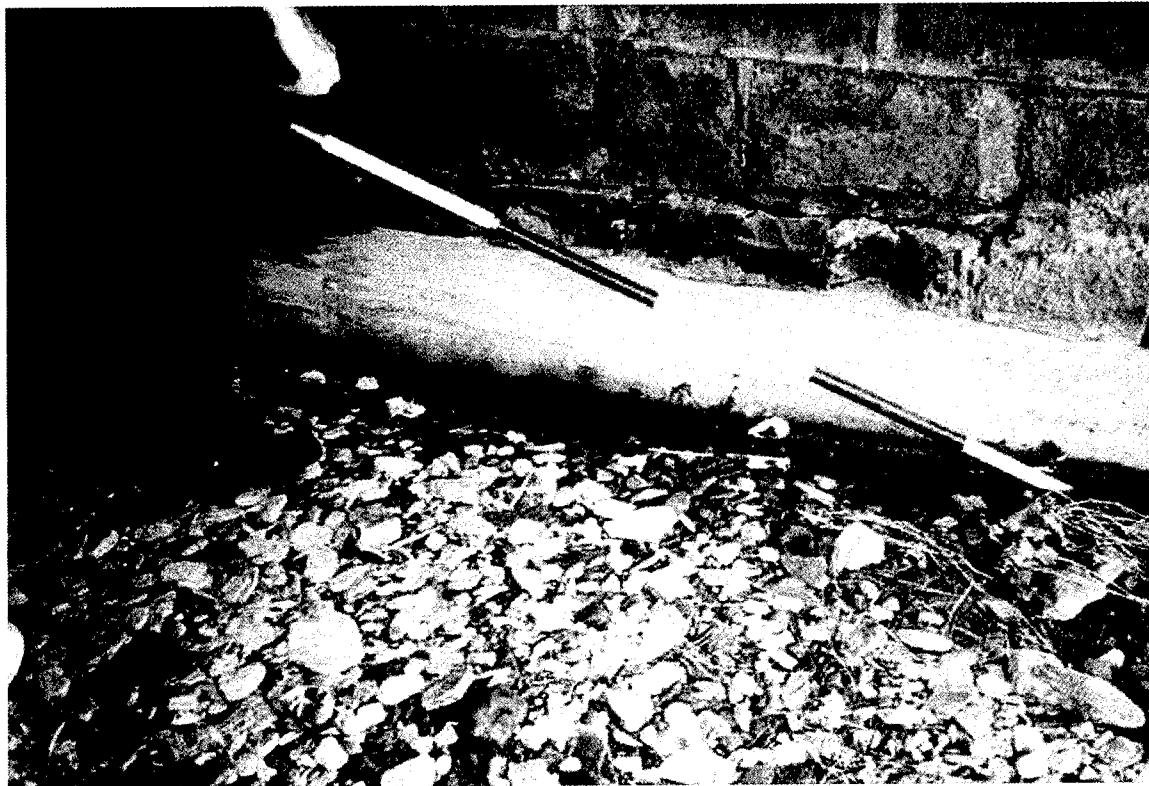
**Carter County US 60 Fleming Fork**

**Bridge # 22-B00041**

**Constructed 1923**

**No Major Problems**  
**Footer Slightly Exposed**

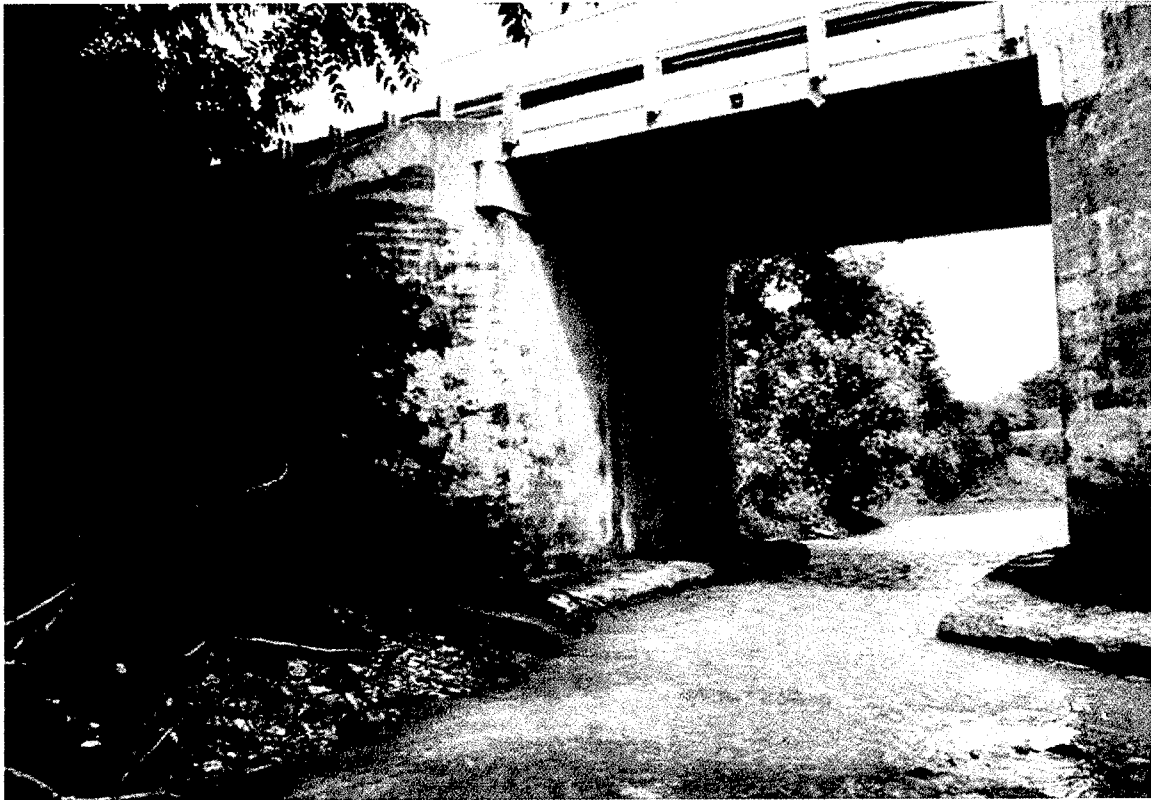
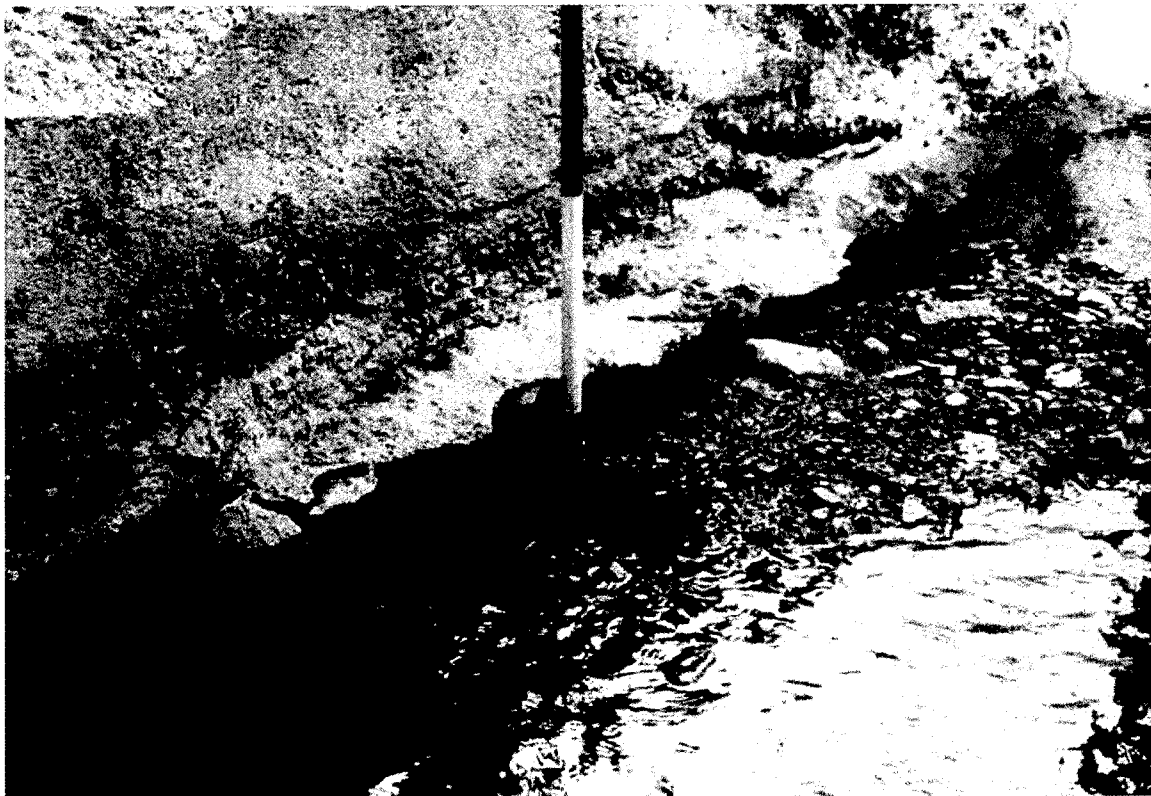
**Cumberland County KY 704 Pine Branch**

**Bridge # 29-B00055**

**Constructed 1987?**

**Footers Exposed**

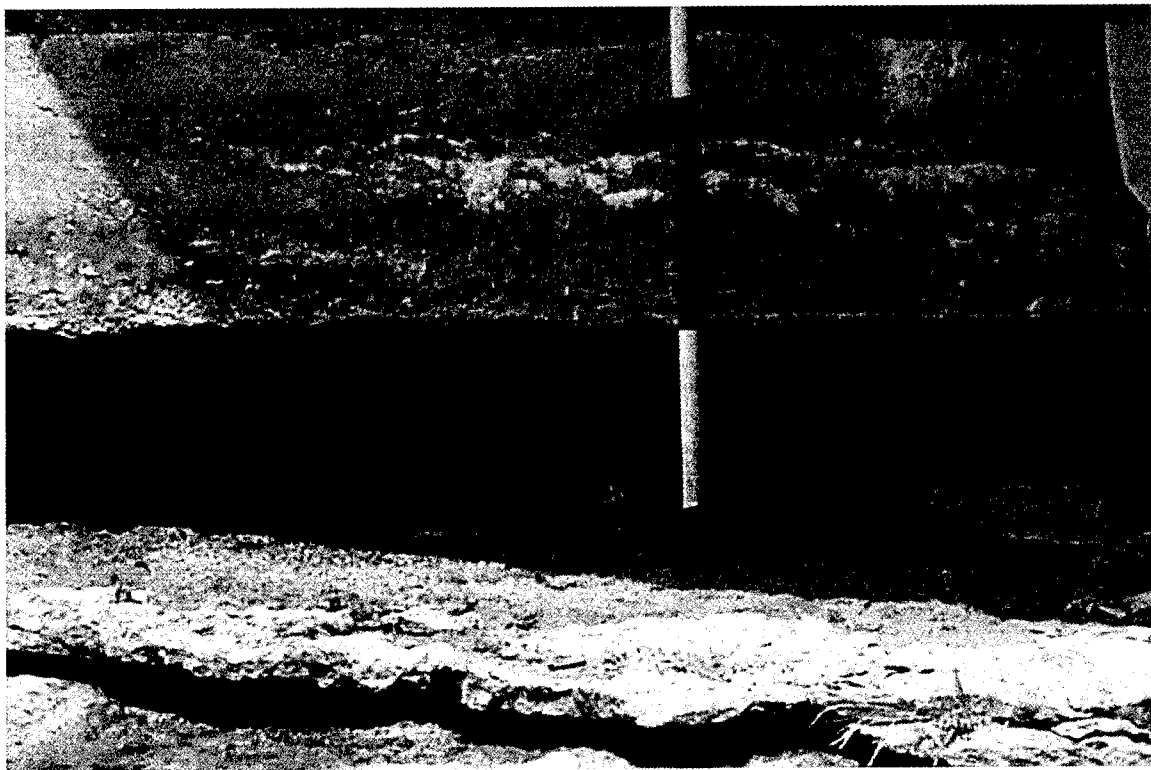
**Harrison County CR 1006 Elk Lick Creek**

Bridge # 49-C00006

Constructed 1981

Scour Rating = 327 Consultant

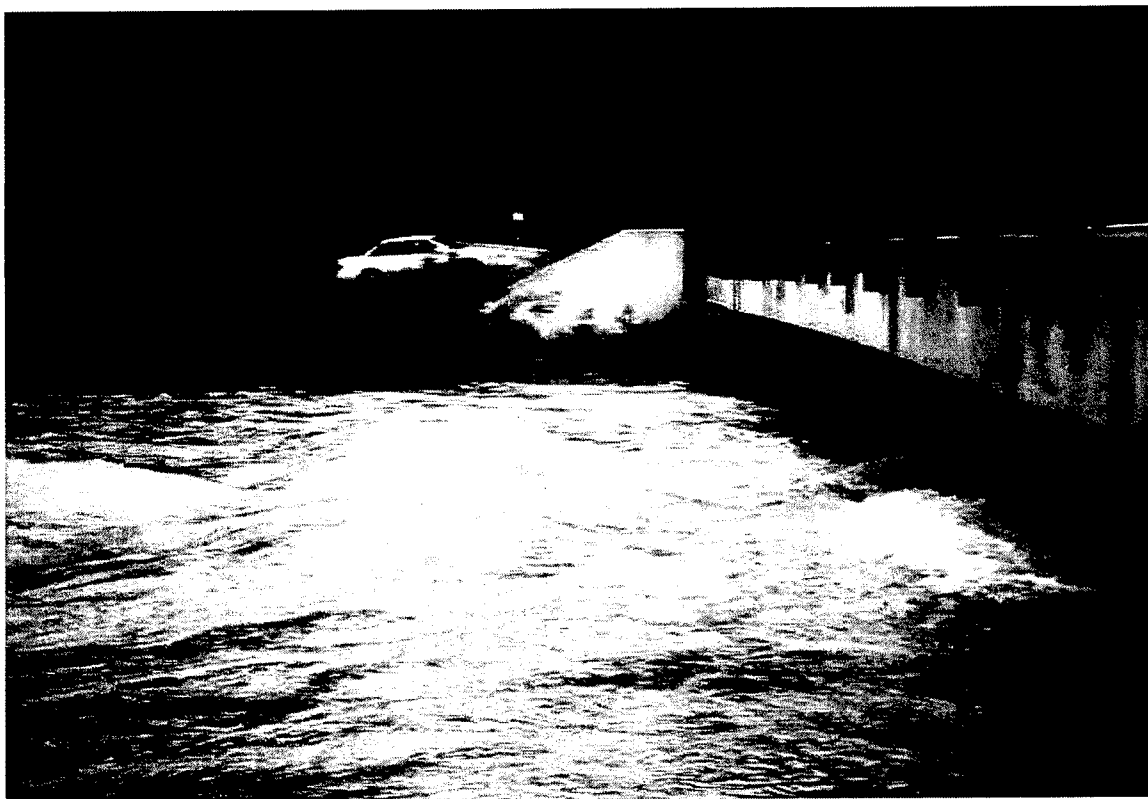
## Jessamine County Elm Fork Road Hickman Creek

**0.5 Feet Scour below Abutment Footer**  
**2 Ft. Penetration Scour**

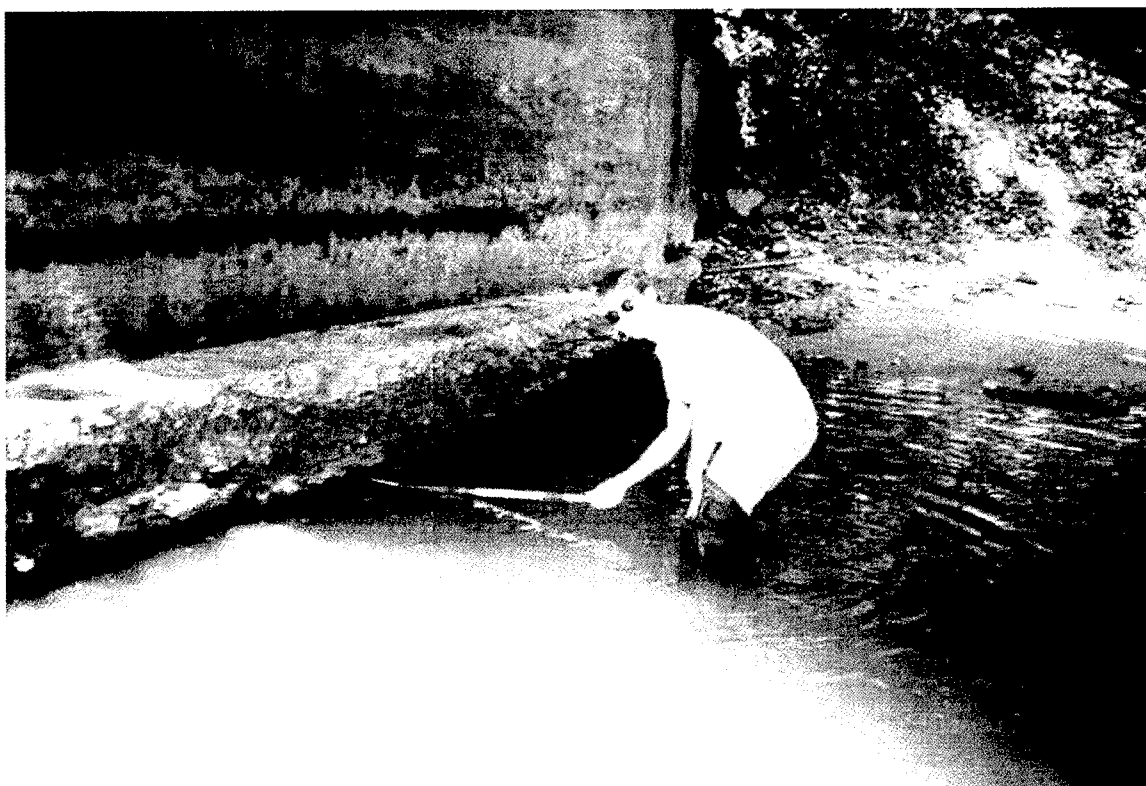
**Lawrence County KY 707 Adam's Branch**

**Bridge # 64-B00035**  
**Constructed 1930 - 1933?**  
**Scour Rating = 401**  
**5 Ft. Penetration Scour**  
**3 Ft. Scour Below Footer**

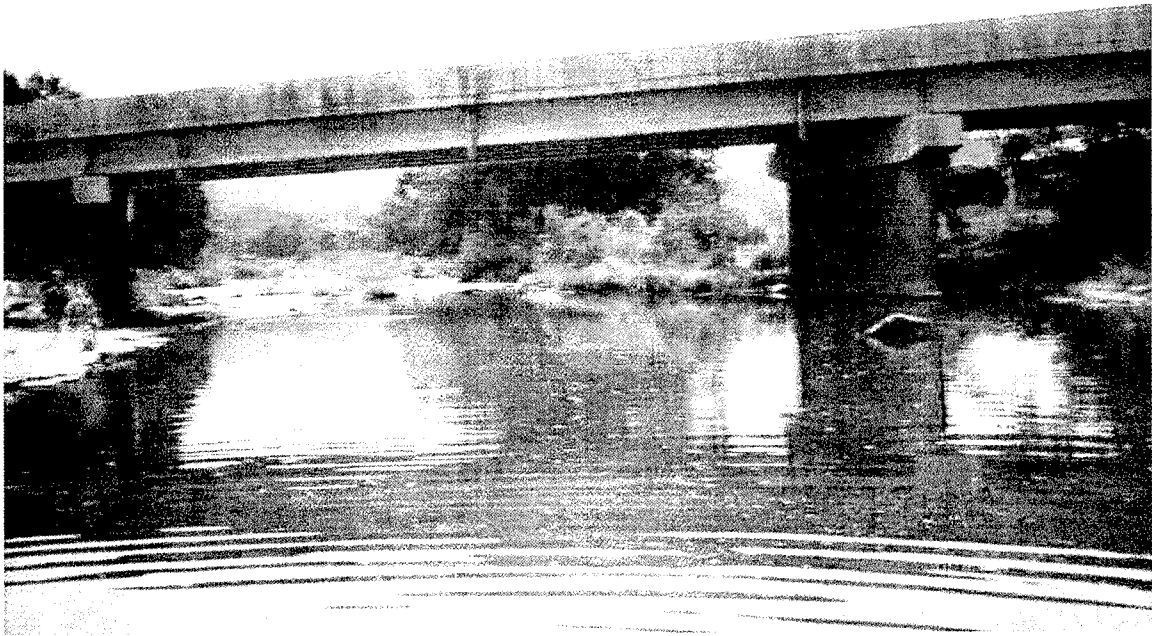
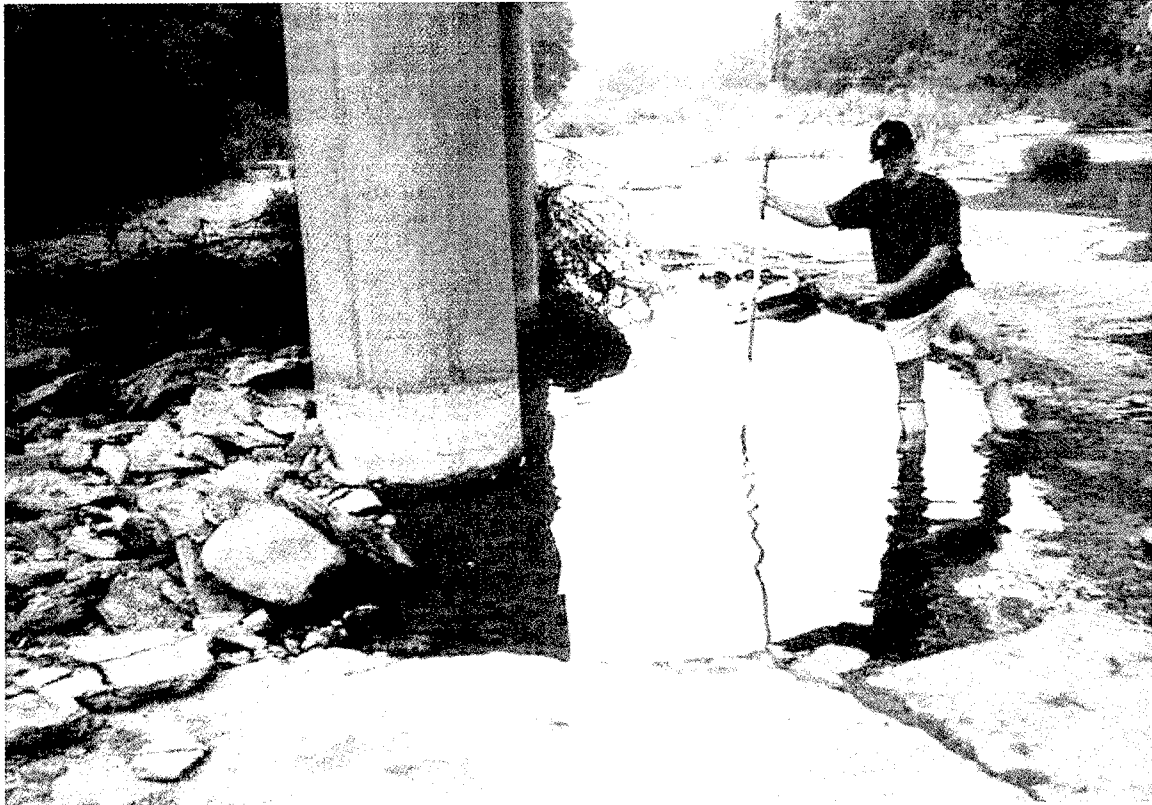
## KY 607 Owen County Cedar Creek

Pier Footer Partially Exposed

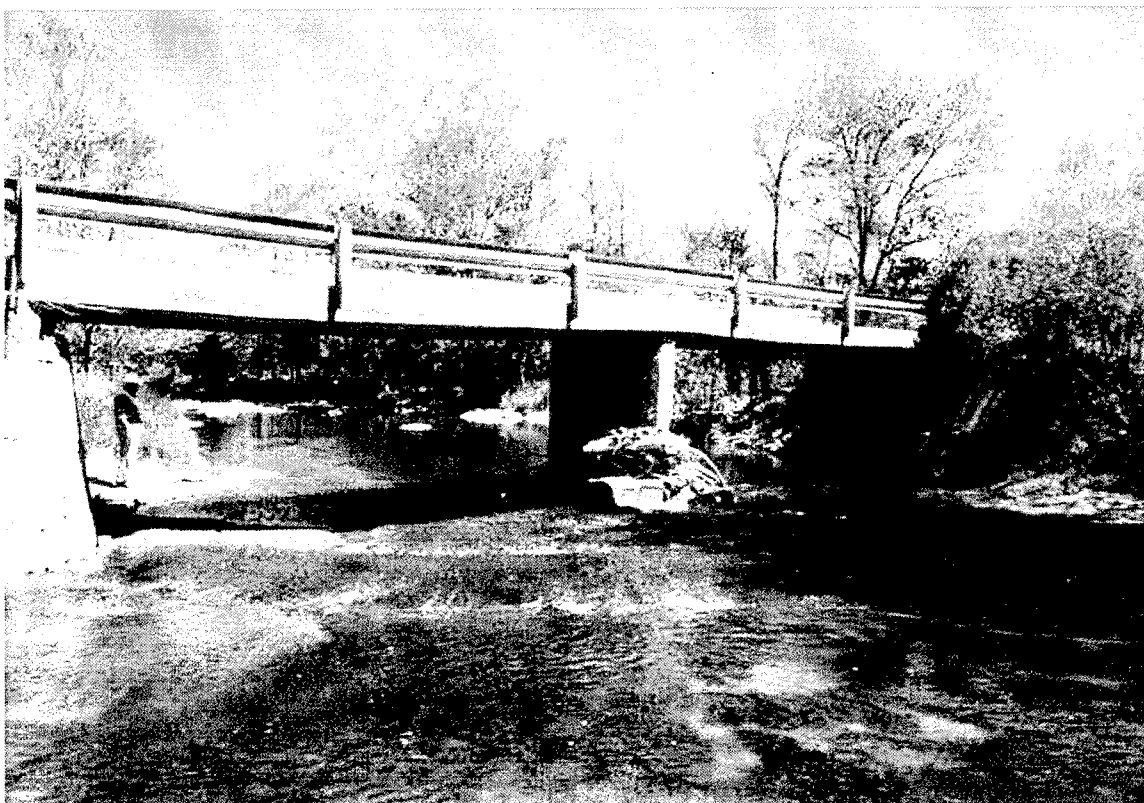
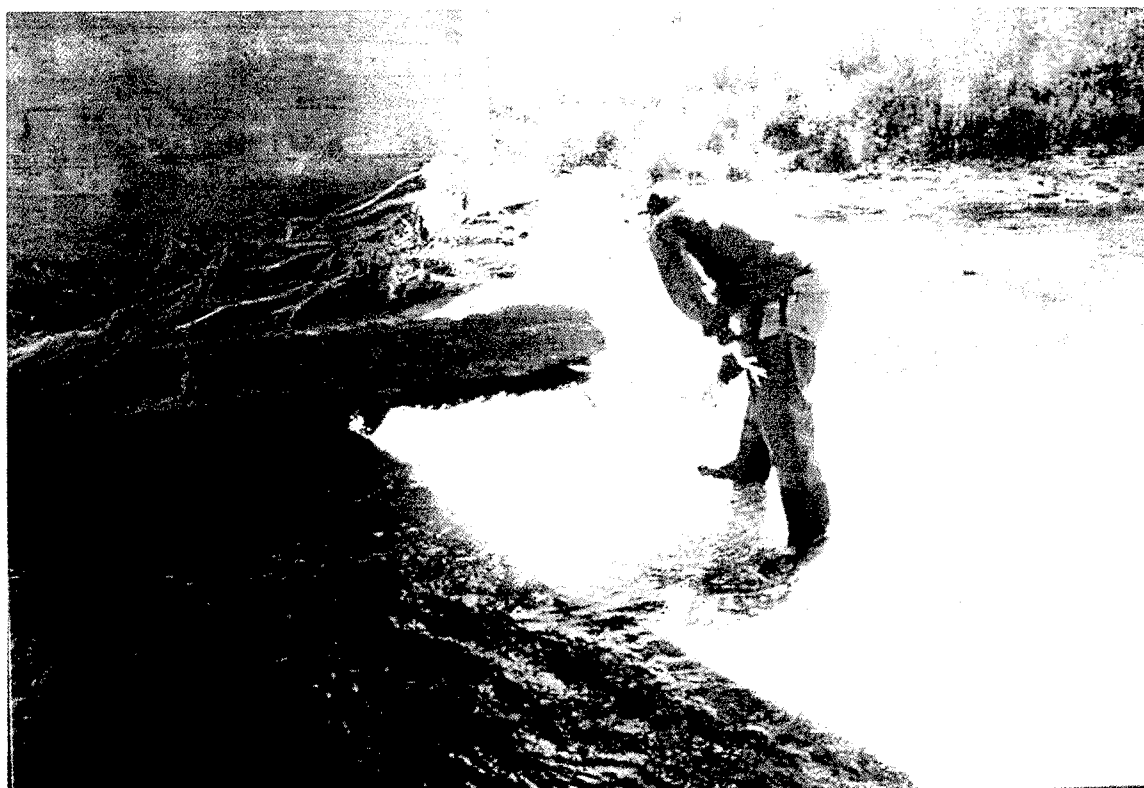
## Washington County CR 1243 Road Run Branch

**1 Ft. Vertical Scour and  
 3 Ft. Penetration Scour at Pier**
